# Rail Accident Report

## **Derailment of a passenger train near Walton-on-Thames, Surrey 4 March 2024**

Report 04/2025  
February 2025

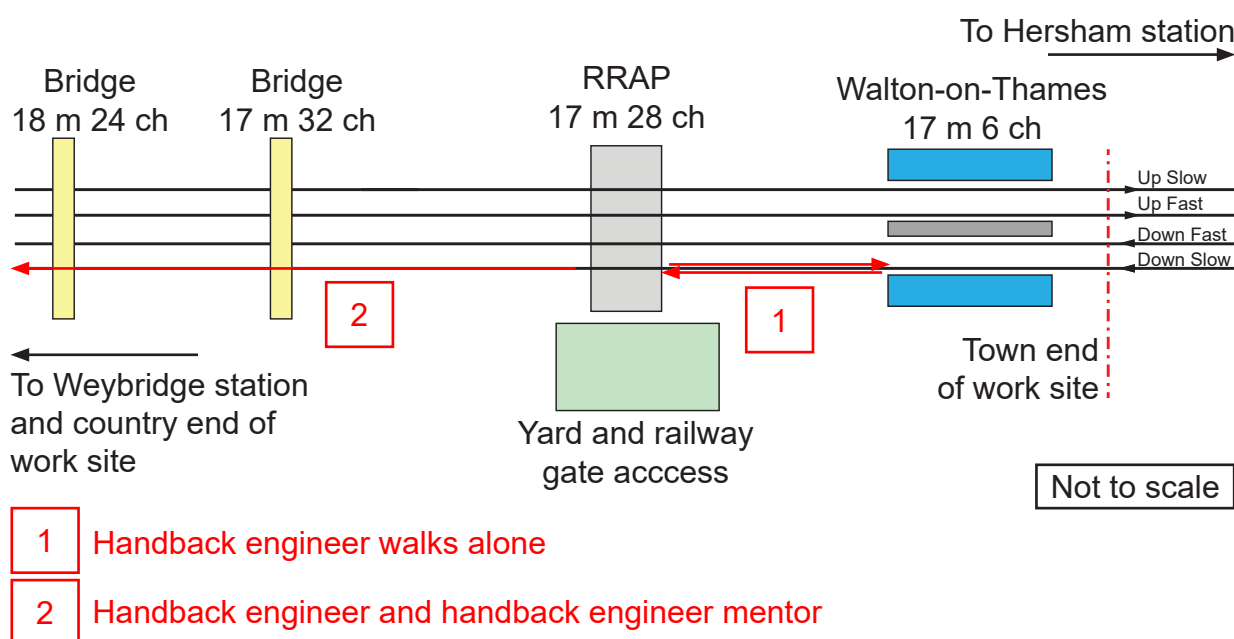
- 51 After this briefing, the handback engineer began the inspection, walking from the RRAP to the town end of the work site, near to Walton-on-Thames station (figure 10). Witness evidence shows that the handback engineer undertook this visual inspection walking in the four-foot of the Down Slow line to check the track geometry. In parallel, the handback engineer also looked for redundant rail in the Down Slow line and looked across to the Down Fast line for any redundant rail that had been left foul of the running line. Witness evidence also shows that this part of the inspection was completed without the handback engineer mentor being present and that the handback engineer used a handheld torch to illuminate the track around them (see paragraph 156).

Figure 10: Diagram of work site, showing the routes walked by the handback engineer and handback engineer mentor from 23:00 on 2 March.
