Report on the investigation of
the double fatality and subsequent loss
of the small commercial vessel

Calypso 2

near West End, Anguilla

REPORT NO 6/2025

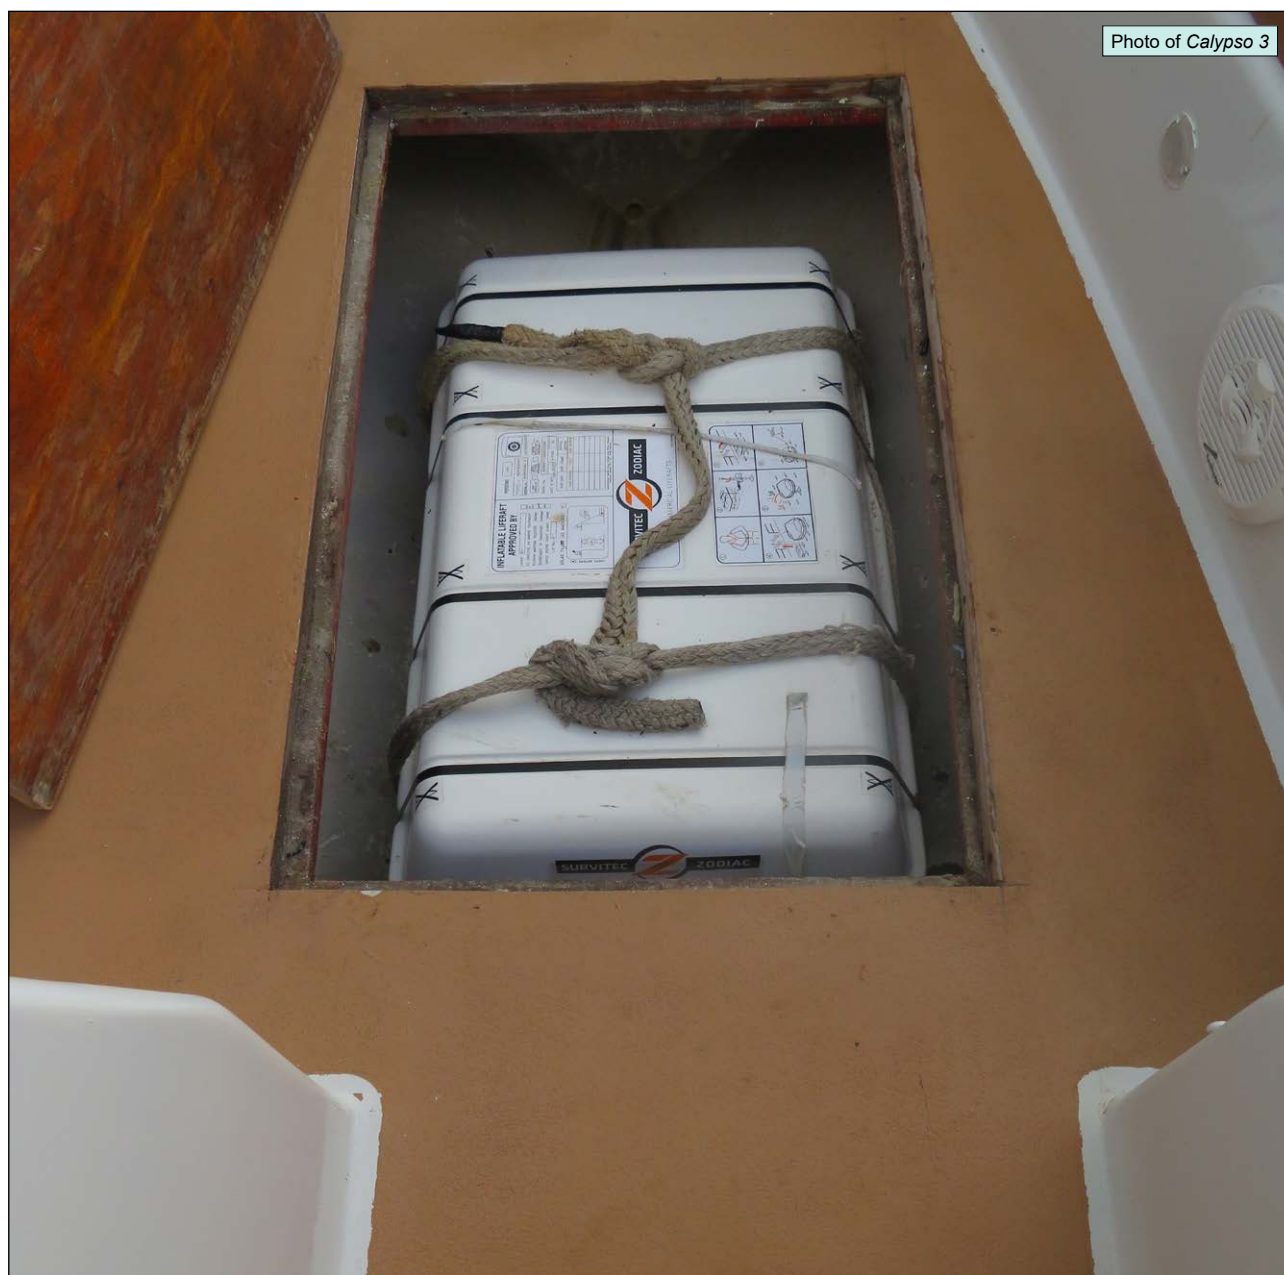
Figure 8: Liferaft stowage in the foredeck seating area

Calypso 2 was equipped with 14 solid foam adult lifejackets suitable for persons weighing over 43kg and two child lifejackets. These were stowed under the seats in the bow. There was one 16-person liferaft in a hard case container stored under the foredeck seating area (**Figure 8**). The vessel carried: a pack of pyrotechnic flares, comprising two orange smoke floats, six red parachute flares and six handheld flares; two lifebuoys, one with a light and one with a line; and two fire extinguishers.

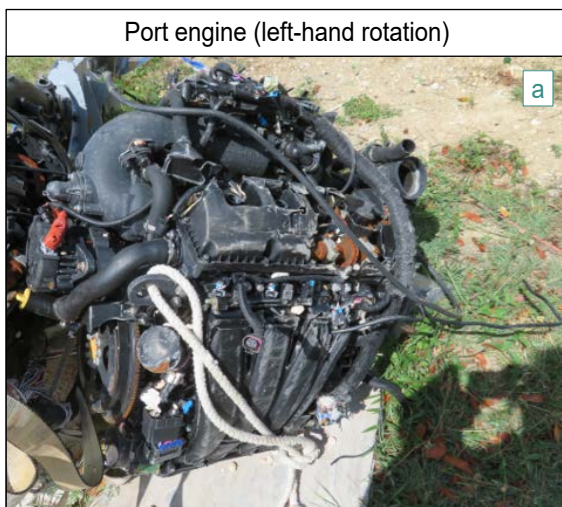
Figure 10: *Calypso 2*'s engines after the accident

- Both engines showed damage from immersion in seawater.
- The port engine had lost its lower leg unit, including the gearbox and propeller.
- The starboard engine was almost complete and the propeller was still in place, though the blades were bent.

- The port engine (left-hand rotation) had no useable electronic data that could be obtained from the unit (**Figure 10a**).
- The starboard engine (right-hand rotation) showed evidence that the engine was in neutral or stopped when it came into contact with the ground.
- There was no brush damage on the propeller blades and no evidence of torque stress damage to the propeller drive splines. The drive pin was intact and the propeller hub was still theoretically useable (**Figure 10b**).
- There was no evidence to indicate that either engine had hydraulically locked⁹.

The post-accident examination of the engines indicated that they were not operated at high power just before they became damaged. This also suggests that the helm was either unmanned or, if someone was at the helm, they did not take effective action in sufficient time to avoid being swamped.
