# Decommissioning Close Out Report

## Harding Submerged Turret Loading System

**HAR-01031-PRM-PM-REP-0007-TAQ**

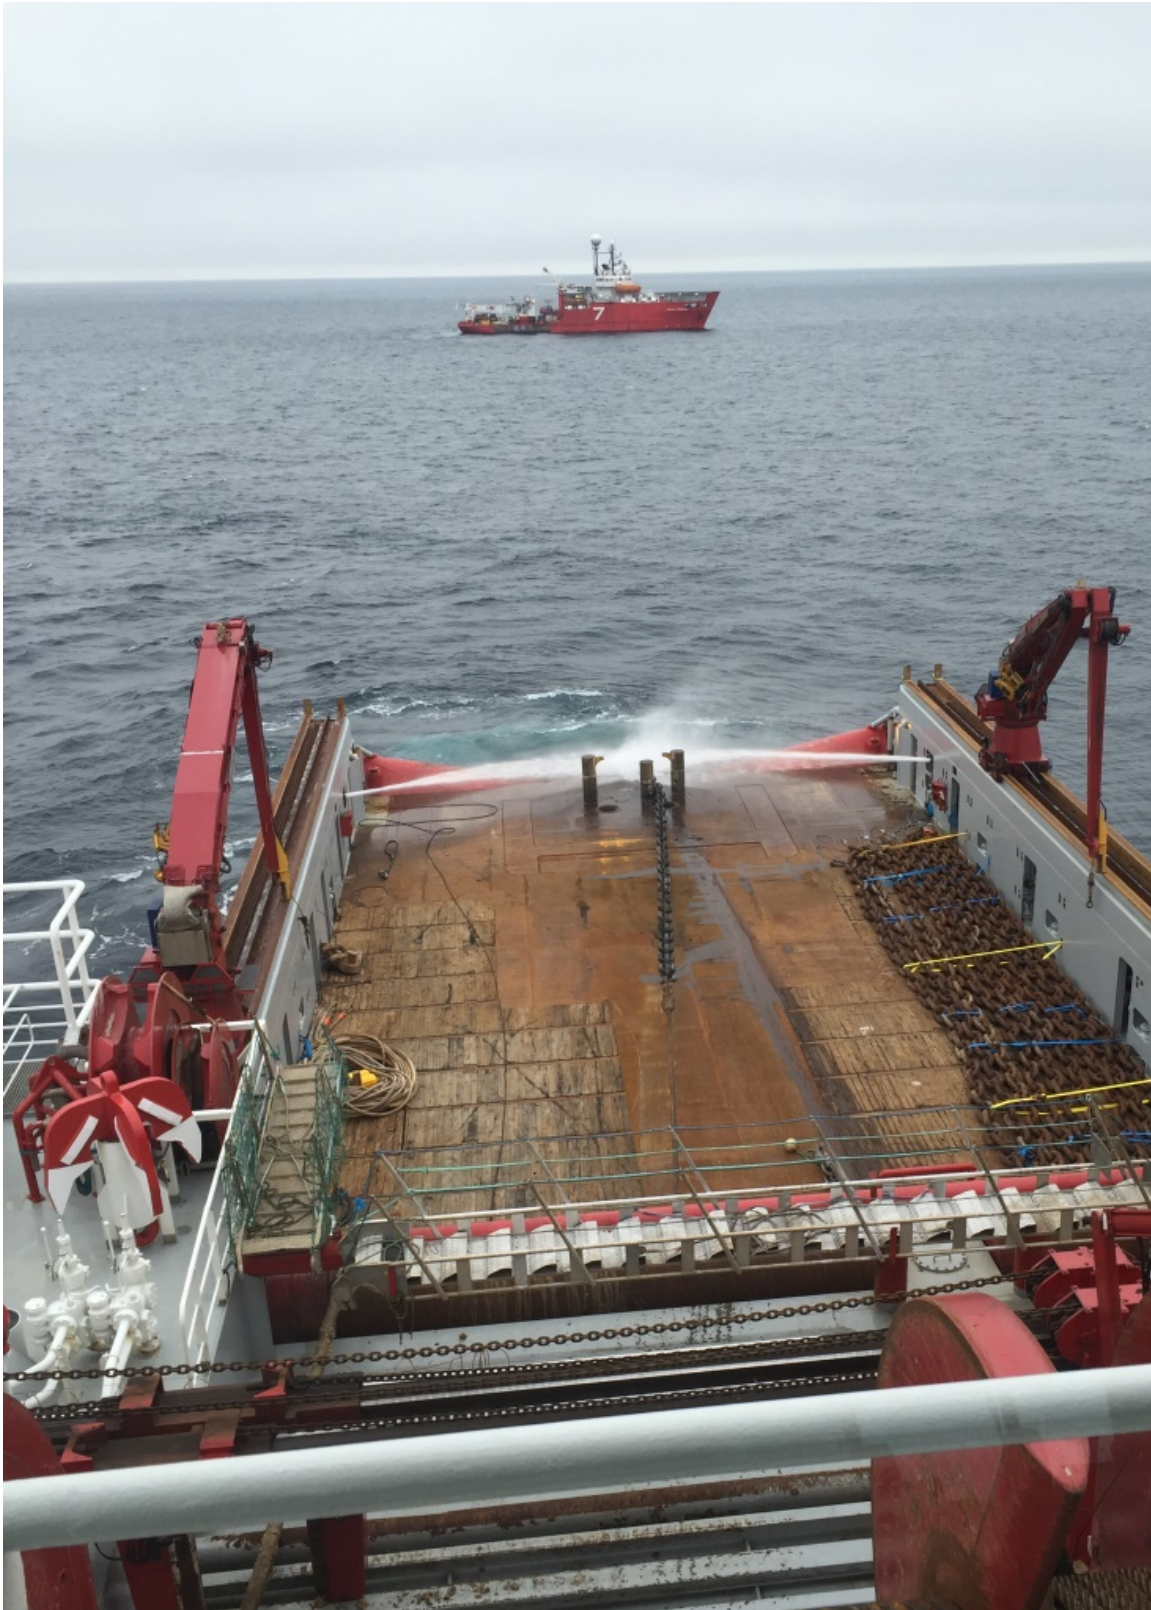
Figure 7.1 AHT recovery of anchor chain

To remove the mooring legs, divers excavated to expose the buried chain, within 10m, to the suction anchor and attached a grommet (wire loop) to the chain. The chains were cut, by either WROV or divers, adjacent to the grommets and the AHT attached to the grommets and pulled the chain and wire to its deck. A WROV cut the wire at the STL buoy to allow the AHT to complete the recovery.

5 – 10m length sections of chain remained attached to the anchors and were recovered with the anchors.

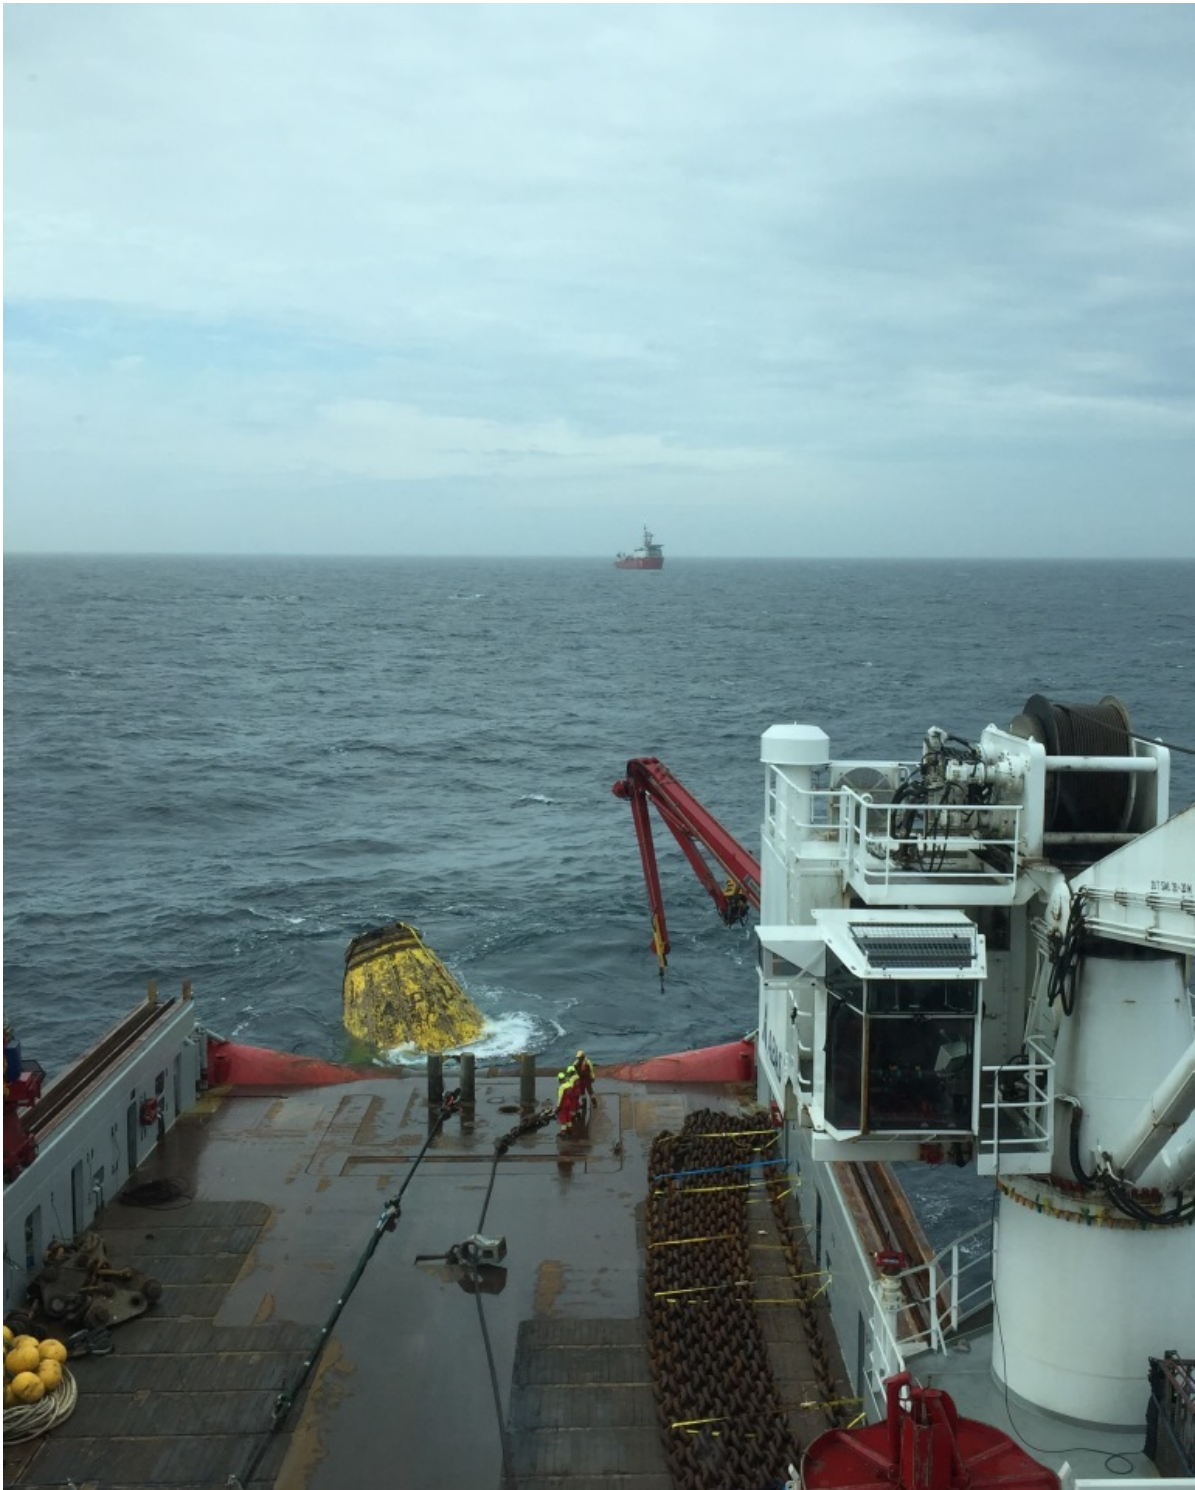
Figure 7.2 AHT preparing STL for tow to Lerwick

Once all mooring legs and offloading riser were removed, the STL buoy was removed from the field under tow by an AHT and taken to Lerwick. The buoy was lifted from the harbour at Lerwick and stowed on a purpose-built support stool.

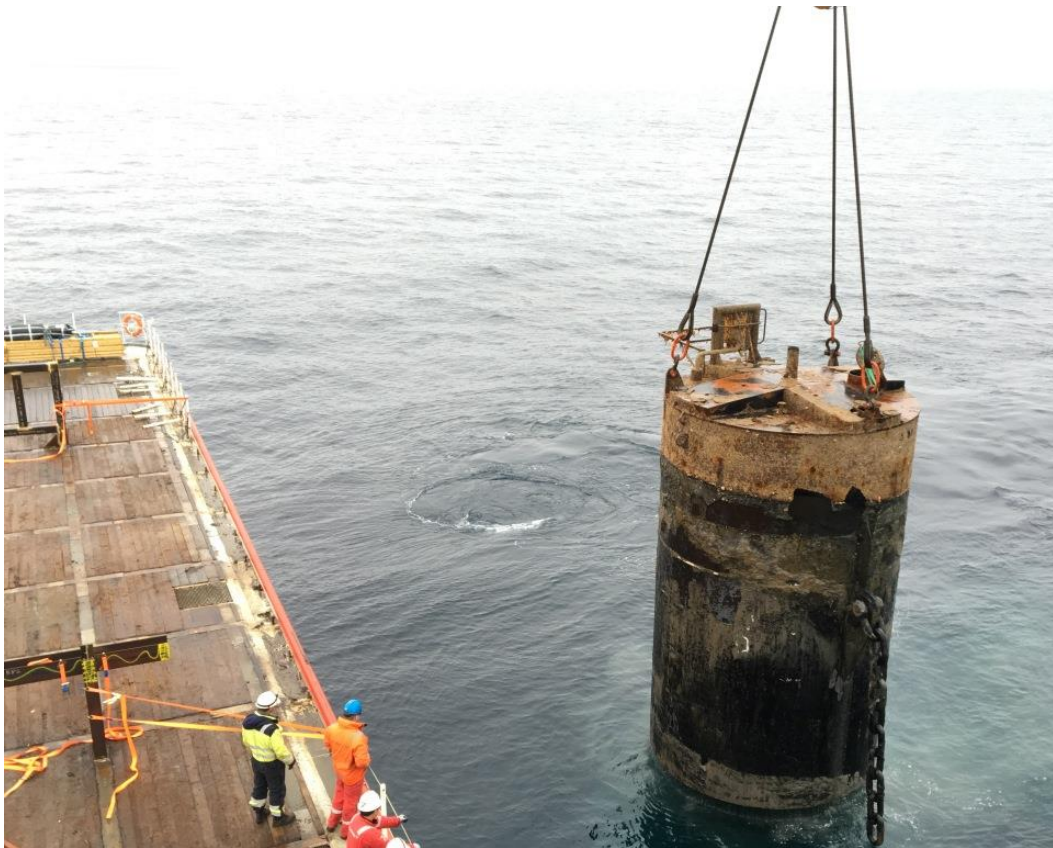
**Figure 7.3 Anchor being recovered to deck of CSV**

The suction anchors, including a short section of mooring chain, were all successfully removed, by a CSV using the reverse installation method and were shipped to Lerwick and off-loaded. The anchors were cut into smaller sections and recycled as scrap steel.

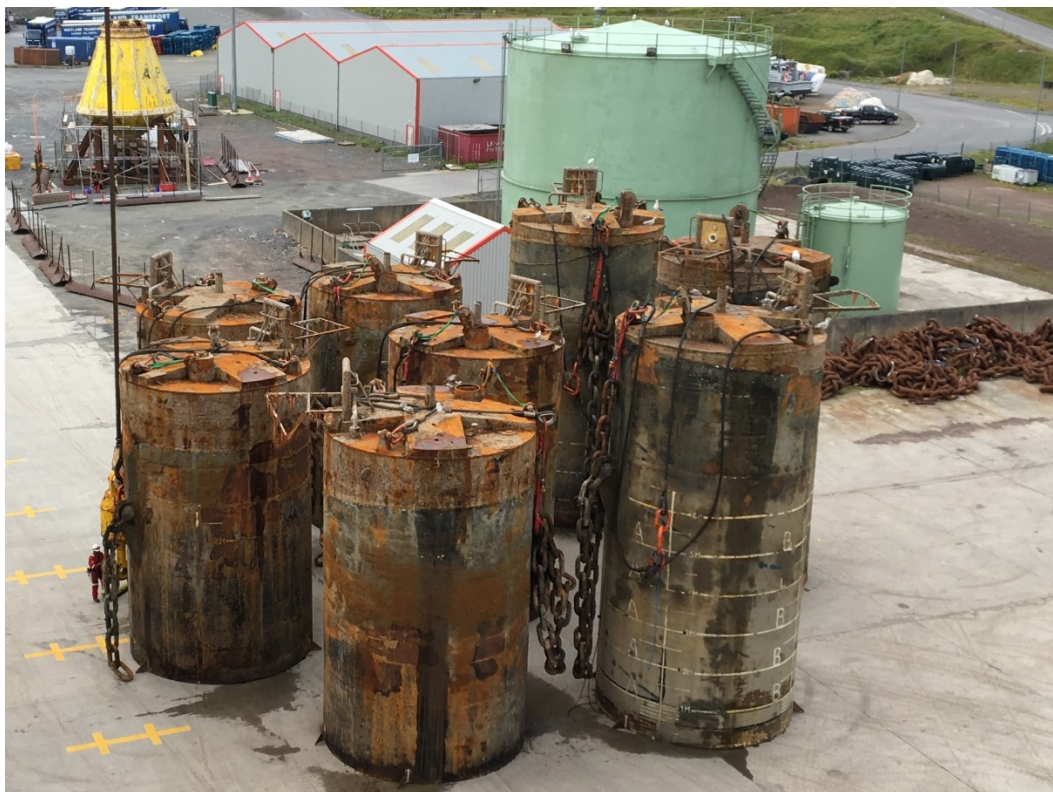
**Figure 7.4 Anchors in storage at Lerwick (STL buoy in background)**
