# Rail Accident Report

## **Derailment of a passenger train near Walton-on-Thames, Surrey 4 March 2024**

Report 04/2025  
February 2025

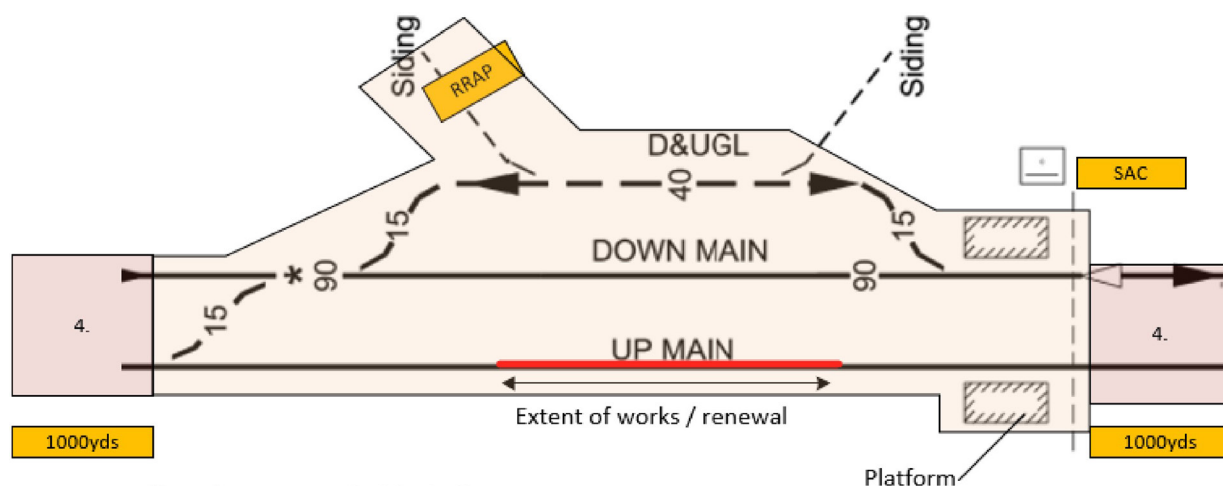
Affected Area Example (shaded):

1. RRAP: Used for on / off tracking machines in siding.
2. All tracks travelled by machines travel including through S&C to and from site.
3. Staff accessing / egressing through platforms from SAC may affect platform areas tidiness or materials left on the platform.
4. Track Handback Engineer to inspect 1000yds either side of affected mileage or upto marker boards – whichever is less.
