Report on the investigation of
the double fatality and subsequent loss
of the small commercial vessel

Calypso 2

near West End, Anguilla

REPORT NO 6/2025

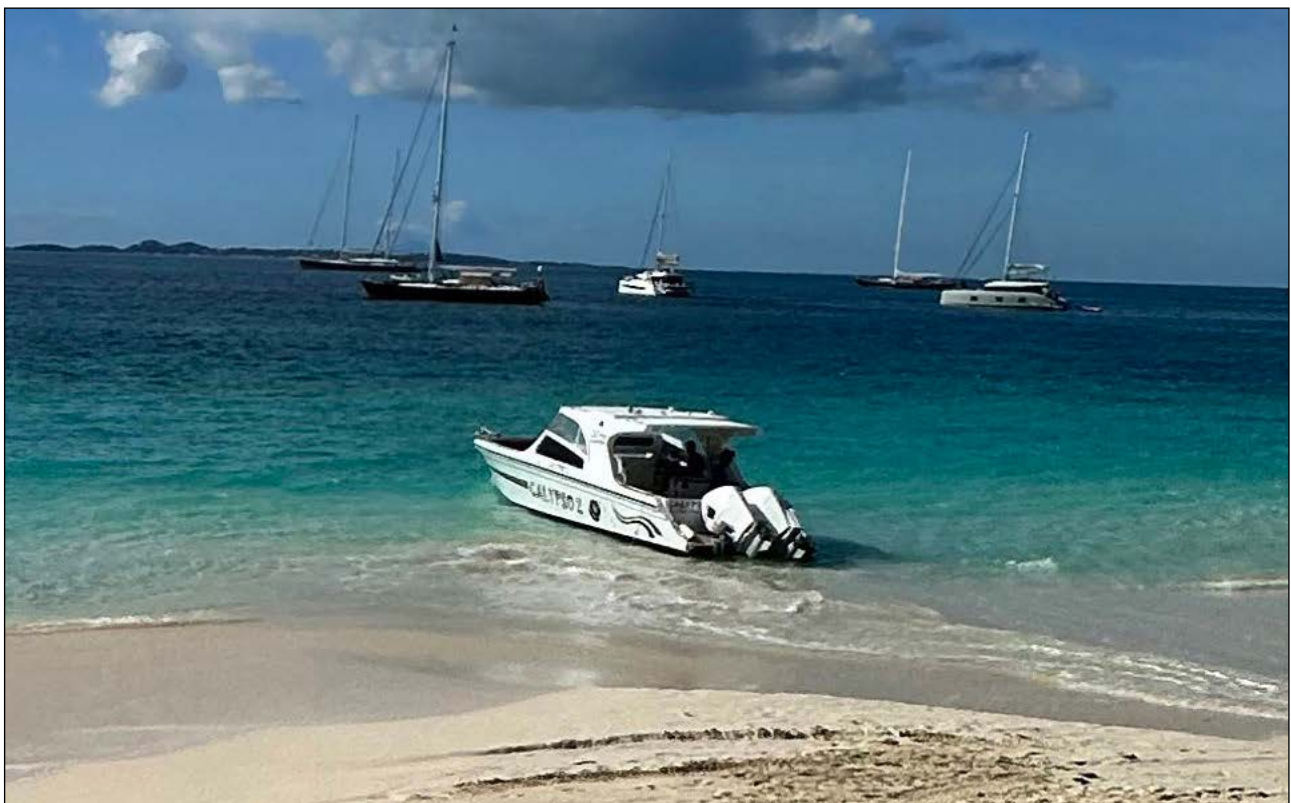
Figure 2: *Calypso 2* at Rendezvous Bay on 11 March 2023

On 11 March 2023, the weather at Rendezvous Bay was fine and clear with rippled seas. By 0930, the small commercial vessel *Calypso 2* was anchored stern to the beach (**Figure 2**) ready for the scheduled excursion.

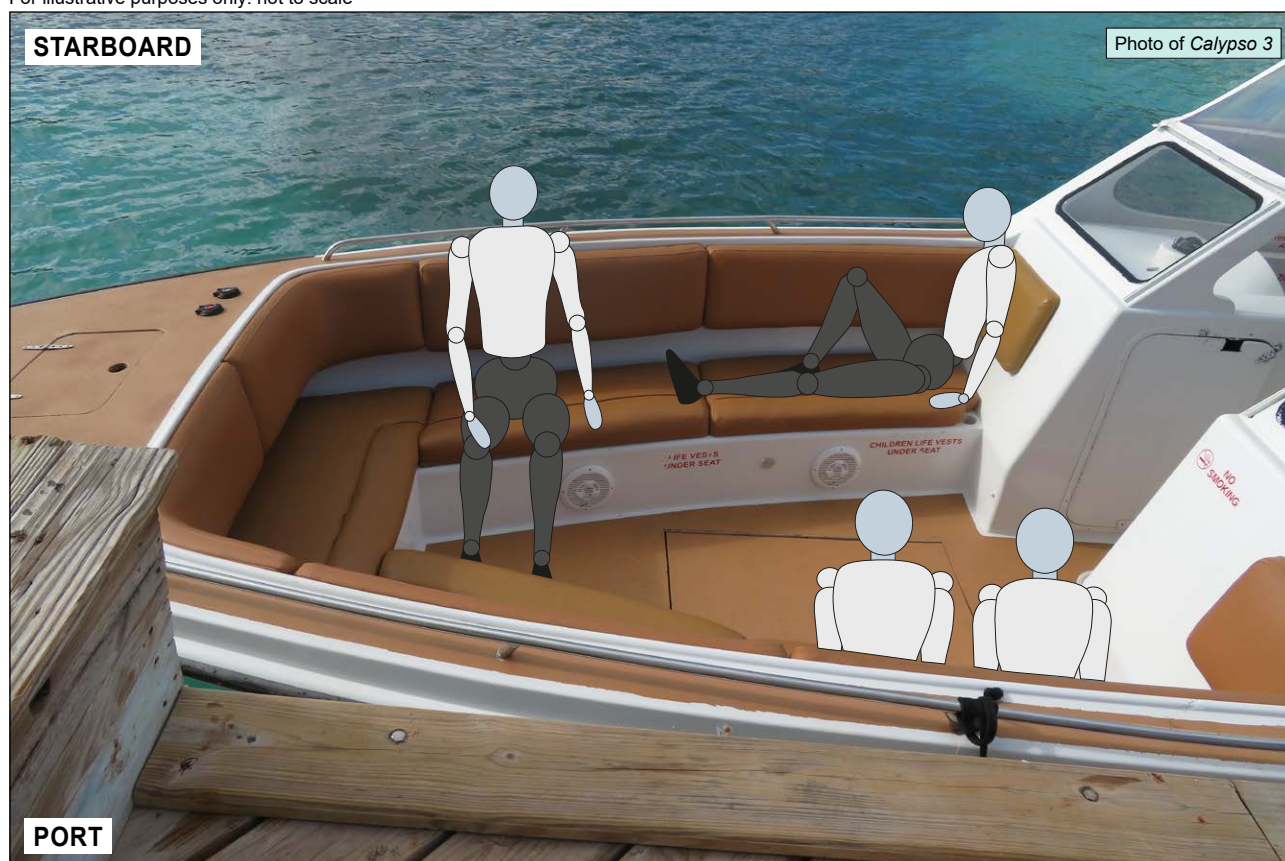
Figure 3: Passengers' seating positions on the foredeck

The family settled in the seating area on the open foredeck, with the two parents sitting on the port side and their son and daughter on the starboard side (**Figure 3**). The skipper manoeuvred the vessel in a south-westerly direction, intending to follow the coast around the southernmost point of the island then along Anguilla's northern coast to the popular tourist location of Crocus Bay (see **Figure 1**).

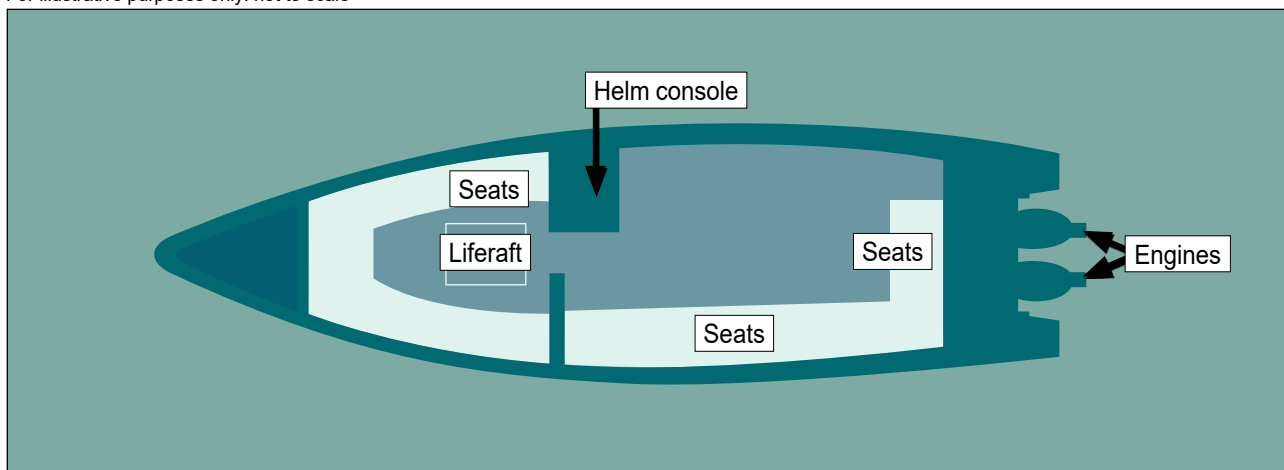
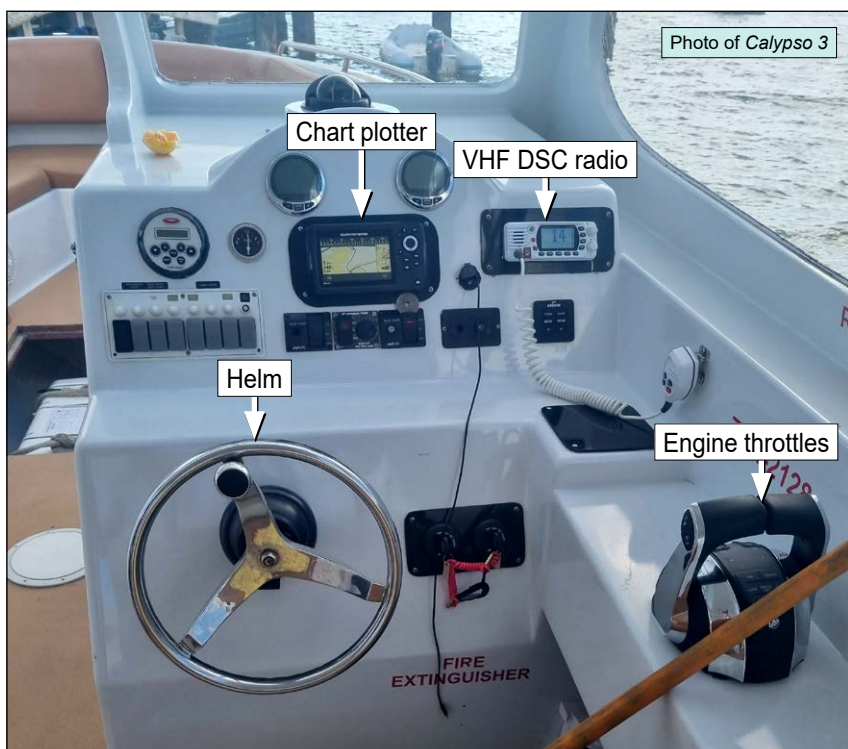
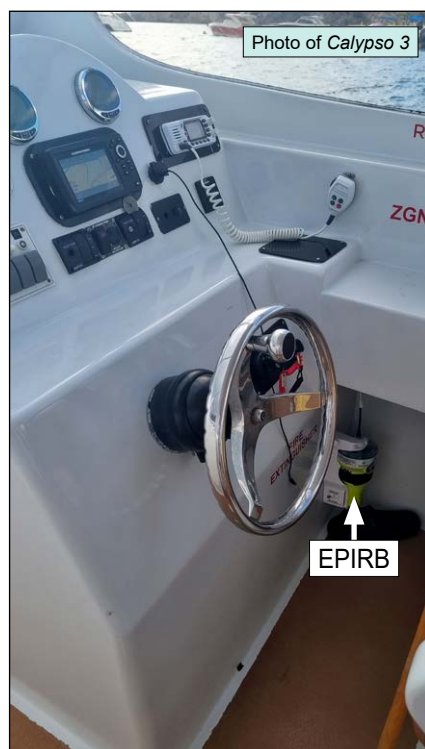
Figure 6: Calypso 2 general arrangement and helm console

Calypso 2 was built for CCL in Trinidad in 2011 by an unknown manufacturer. The vessel had a planing hull constructed from glass reinforced plastic and twin 350 horsepower outboard engines that had been fitted in December 2022. There were passenger seating areas around the foredeck and across the stern. Approximately one third of the vessel's length from the bow there was a partially enclosed cabin area that included the helm controls on the starboard side, the on board toilet, and a seating area on the port side (**Figure 6**). The stern had a low transom to facilitate boarding from the water.

An Emergency Position Indicating Radio Beacon (EPIRB) arranged for manual release and activation was stowed below the helm console (see **Figure 6**). *Calypso 2* was not equipped with an AIS transponder.

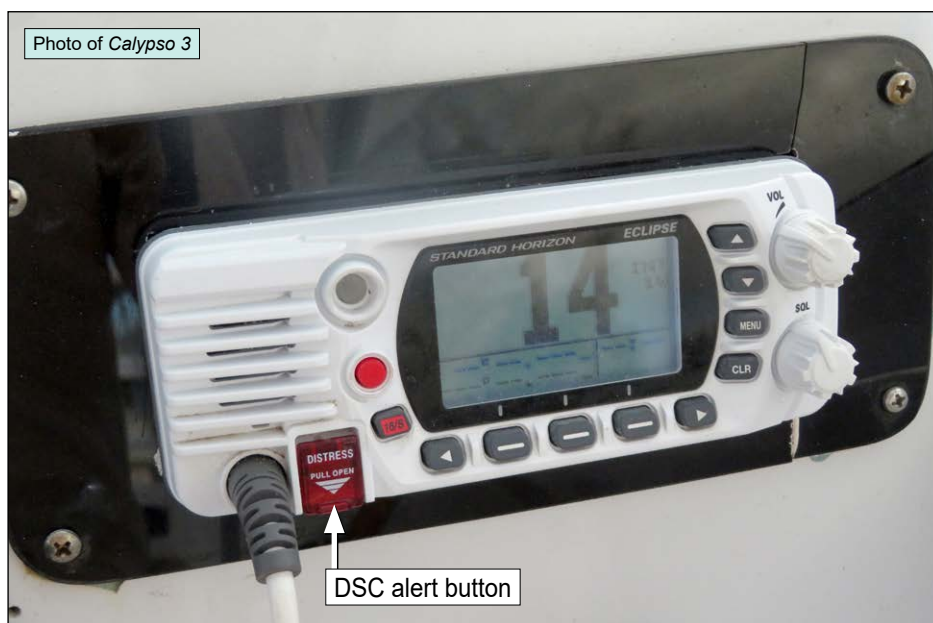
Figure 7: VHF DSC radio

The helm was equipped with engine throttles; engine start-stop buttons; a global positioning system chart plotter; a compass; a bilge pump control; and a very high frequency (VHF) digital selective calling (DSC) radio with an alert button (**Figure 7**). *Calypso 2* also carried a copy of the Imray A24 paper chart.
